WILDFIRE AND RIVER RESTORATION CHEWUCH RIVER, WASHINGTON

WILDFIRE HISTORY

WILDFIRE EFFECTS ON RESTORATION

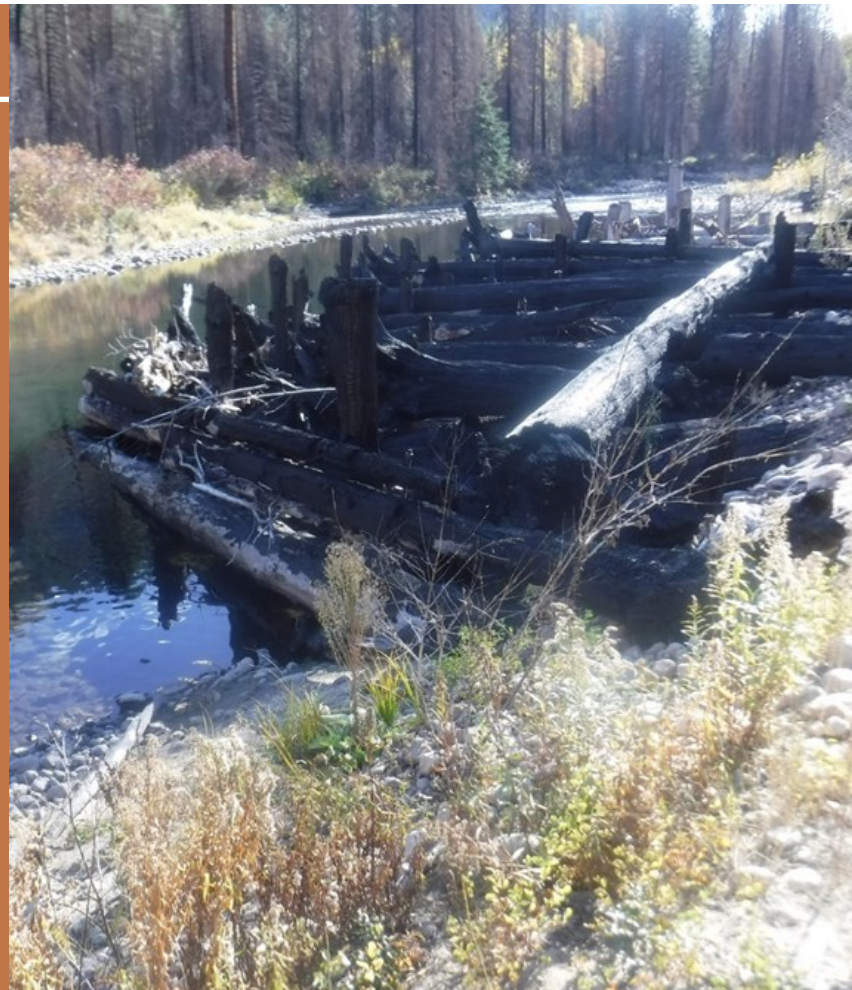
2015 Restoration, Site Q

- Buried large wood structure remained similar in shape and function until fire
- Structure still has structural integrity
- Alluvial fan and structure partially buried by mudflow
- Mudflow generated in a steep, severely burned side drainage.

2017 Restoration, Sites B, E, and J

- Inlet apex structure and significant pieces of jam burned, but base layer did not
- Reduced structural integrity and strength at all sites; risk that portions of jams will mobilize during future flows
- Logs, piles, and other key pieces have smaller diameters (some down to 12 inches)
- Some pools and habitat remain after fire

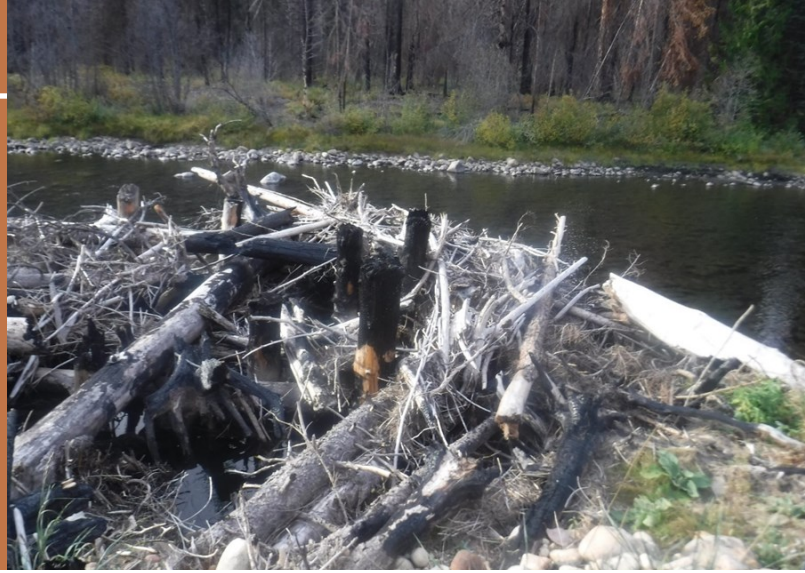
2018 Restoration, Sites L, M, N, and P

- All sites featured pile-ballasted large wood structures extending into channel
- Most of slash and log jam components consumed
- Design integrity lost; possible remaining portions will be removed by future flood flows
- Bottom layers largely remain intact and may collect wood from upstream over time
- Some habitat still maintained after fire
- Largest diameter classes of wood maintained design stability and continues to function and cultivate habitat
