CASE STUDY:

Using the Hazard Mitigation Grant Program to Address Post-Wildfire Flooding in Chelan County, Washington

Project Title: Antoine Creek Culvert Replacement Project

Project Leads: Chelan County Flood Control Zone District and Chelan County Department of Public Works

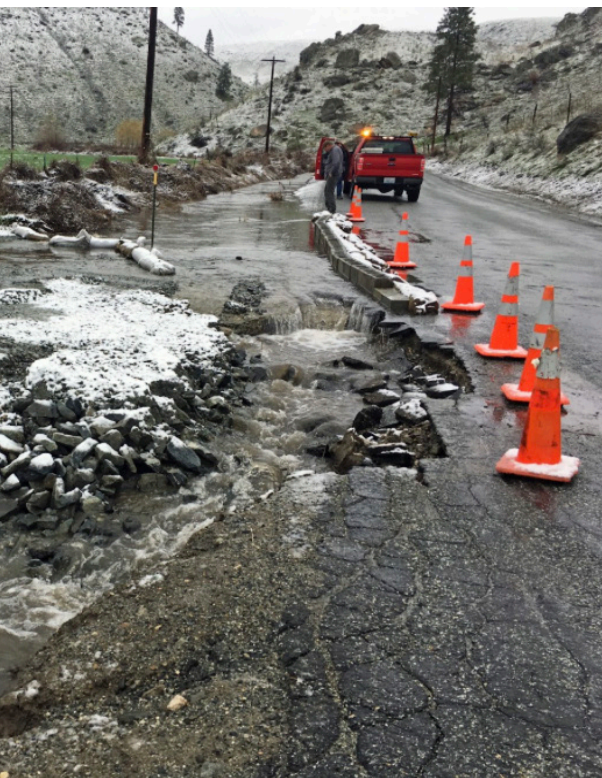
Flooding along Antoine Creek Road before culvert replacement. Photo Credit: Chelan County Public Works

The burn severity within the Antoine Creek basin was high enough that discharge and velocity of surface water flows significantly increased in the following years. During subsequent spring runoff events, three culverts along Antoine Creek Road could not adequately convey the increased quantity of sediment-laden runoff, ultimately causing flooding.

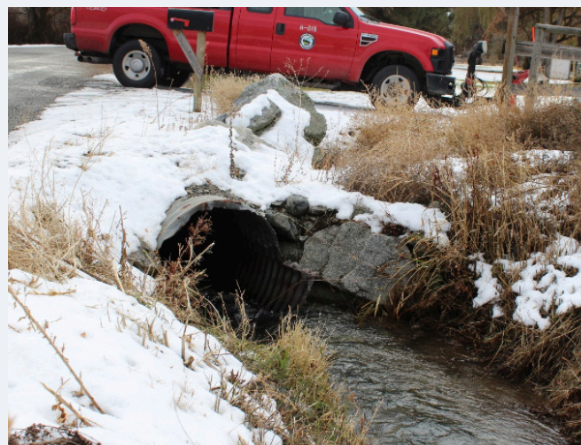
Culvert 3 before replacement. Photo Credit: Chelan County Public Works

- Replacing two 24-inch diameter and one 36-inch diameter corrugated metal pipe culverts.
- Installing three new culverts, each 3-feet tall and 8-feet wide, with variable lengths.

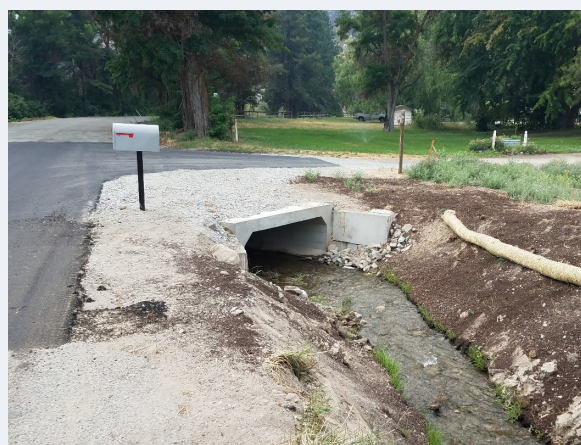
Culvert 3 before replacement. Photo Credit: Chelan County Public Works
