# WILDFIRE AND RIVER RESTORATION WOLF CREEK, WASHINGTON

## CASE STUDY PURPOSE

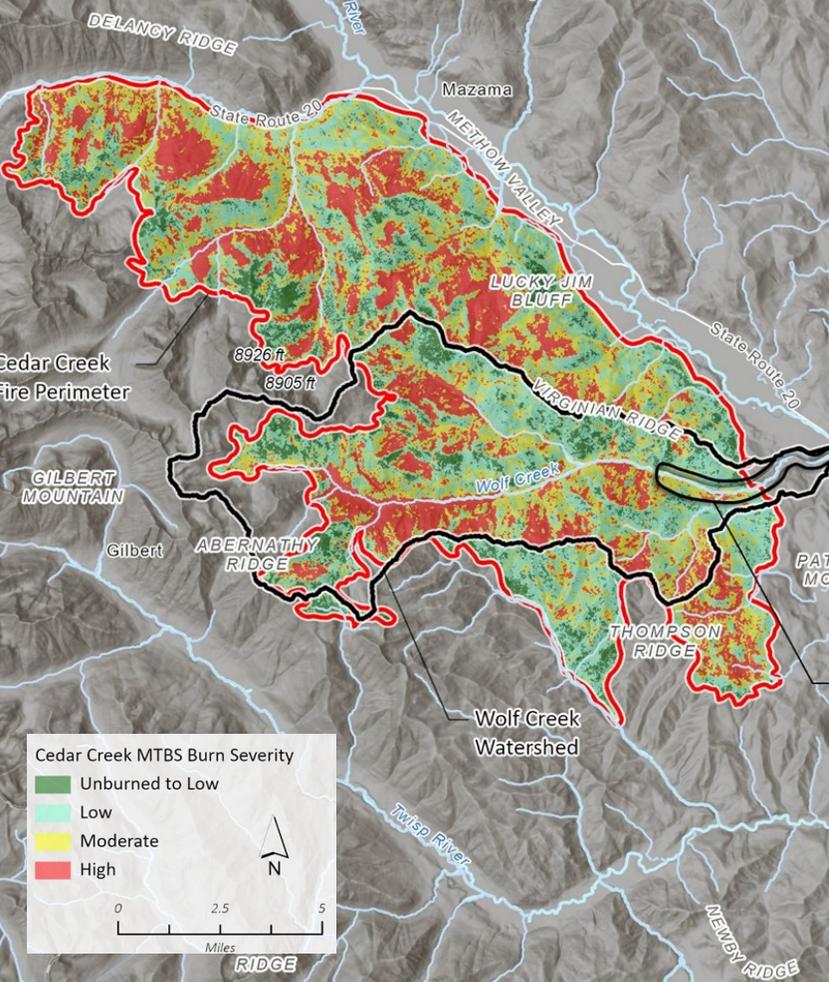
The Cedar Creek Fire started on July 8, 2021, from a lightning strike. It went on to burn 55,000 acres before it was considered contained on August 15, 2021. The fire directly burned about half of the assessment area that is being considered in this case study and burned 80% of the contributing watershed. According to the U.S. Forest Service National Fire Boundary dataset, the Cedar Creek fire is the largest fire within the Wolf Creek watershed in recorded history. The fire history of this watershed shows relatively minimal fire activity in the past 100 years.

According to the Burned Area Emergency Response report, 48% of the burned area within the Cedar Creek Fire exhibited high or moderate soil burn severity with vegetation mortality in these zones ranging from 80 to 100%. Preliminary hydrologic models estimated flow increases in headwater channels to be greater than 100 times the pre-fire flow rates.

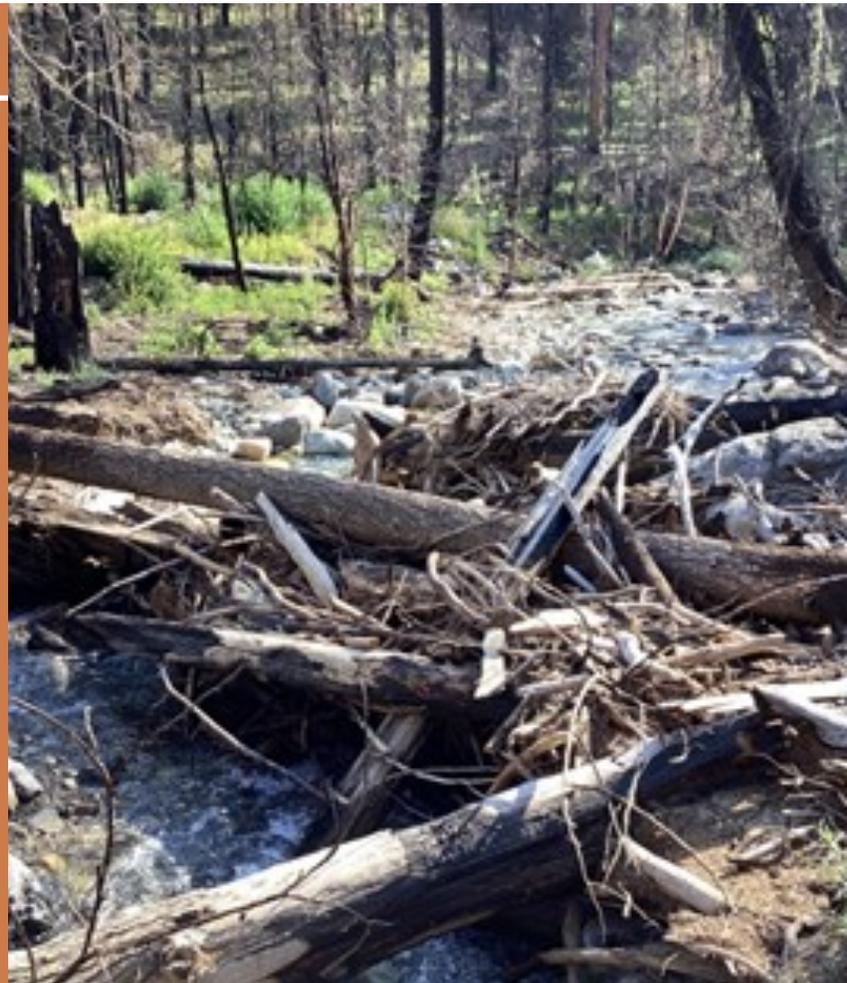
The wildfire effects on the Wolf Creek case study area include impacts to soil, channels, hillslopes, and large wood. A technical memo published in 2021, *1-year Post Cedar Creek Fire Site Walkthrough and Restoration Strategy Recommendations*, made the following observations:

- In areas with high and moderate severity of burn, vegetation and organic matter—including large wood jams—were burned and covered with a layer of ash debris. Less severely burned areas only saw brush and the top layer of soil burned; trees and riparian vegetation survived.
- Large wood jams in areas of Wolf Creek were already below minimum requirements for channels to provide basic habitat complexity for salmonids. The fire burned most existing large wood jams, contributing to a continued lack of large wood pieces.
- The study area saw minimal changes to channel form. Bank erosion from subtle channel widening occurred in areas where the hillslope had failed due to burn-related riparian vegetation loss.

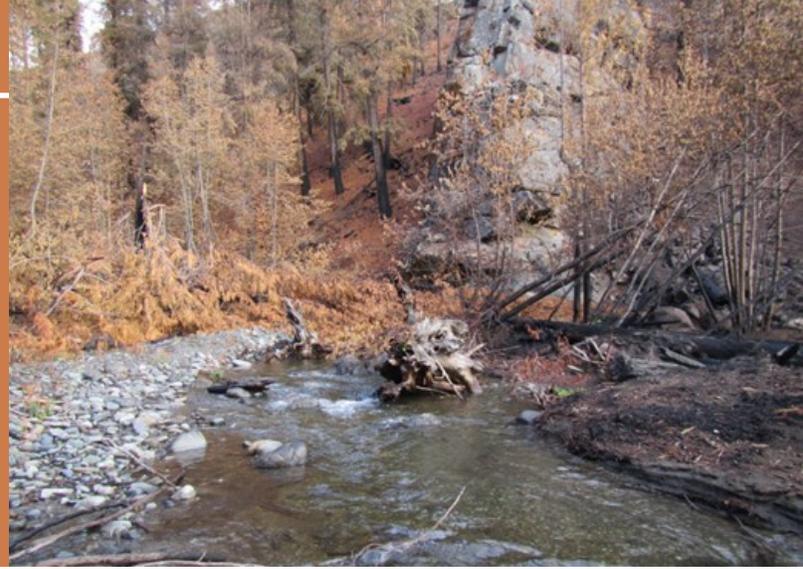
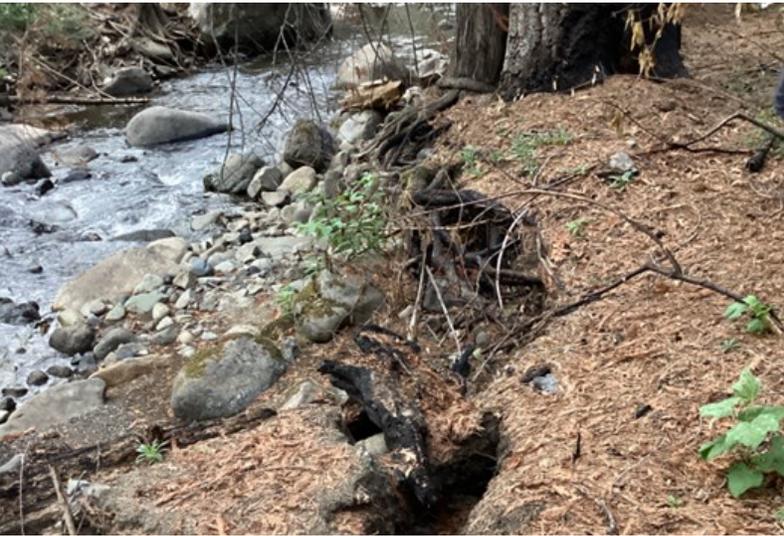
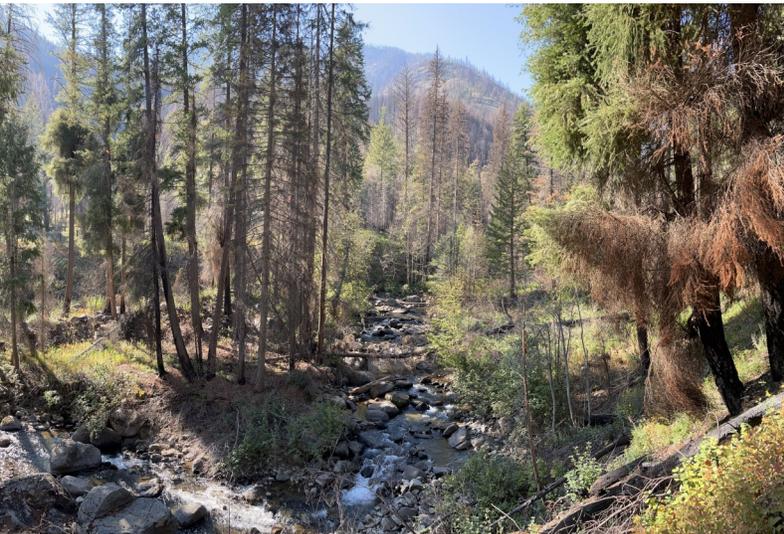
- Increased erosion processes in the first year after the fire produced and transported fines (silt and fine sand) and ash from adjacent unvegetated surfaces into the river channel. Alluvial accumulations of fines rich in ash were observed in low flow velocity areas.
- Large, unstable areas on hillslopes along the river valley are expected to have an increased risk of hillslope failure in the next decade as fire-damaged trees on the hillside decay.

- Natural log jams that were partially burned were within the active channel, had key members that were partially submerged or in contact with the low-flow channel, and were ballasted by alluvium and very large boulders.
