## CASE STUDY:

### Accessing Diverse Funding Streams for Post-Fire Recovery in North Yakima County, Washington

Project Title: Yakima Tieton Irrigation Canal Repairs  
Project Leads: Yakima Tieton Irrigation District and North Yakima Conservation District

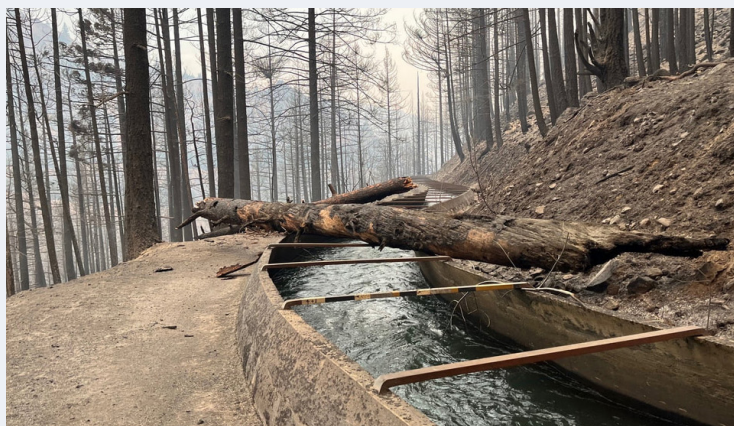
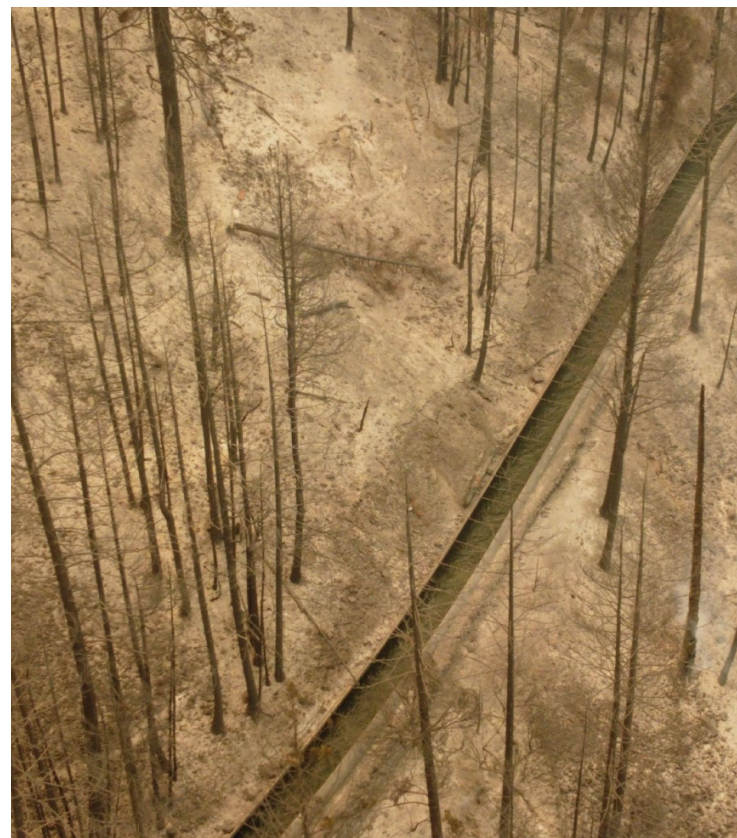
*Trees and massive boulders crashed into the canal, damaging walls and weakening its structural integrity. Photo Credit (above and left): Yakima Tieton Irrigation District*

The effects of the Retreat Fire were felt across both natural and built environments in Yakima County. The fire resulted in the loss of 5 structures as well as the closure of U.S. Route 12. Burn scars dominate the landscape and debris flows have scoured the land around YTID’s main canal. Physical damage from trees, rocks, debris, and slope destabilization continue to threaten the YTID’s main canal to the point of near catastrophic failure. If the main canal fails, there would be cascading impacts on the multi-billion dollar agricultural industry in the West Yakima area. Recovery and mitigation actions are critical to reduce further potential loss and damages to industries, communities, and the surrounding landscape to which everything else is tied.

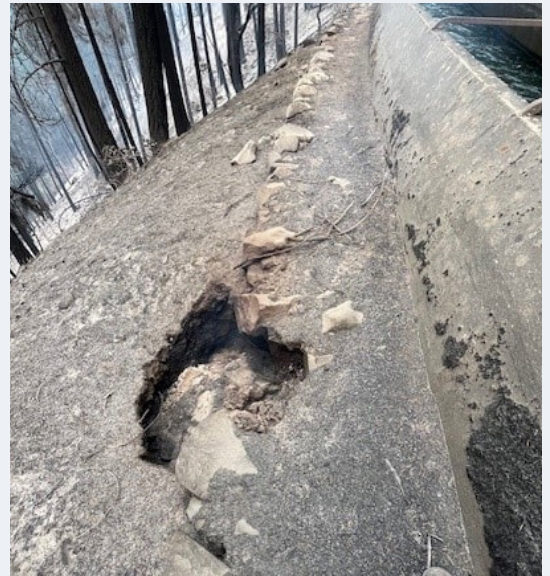
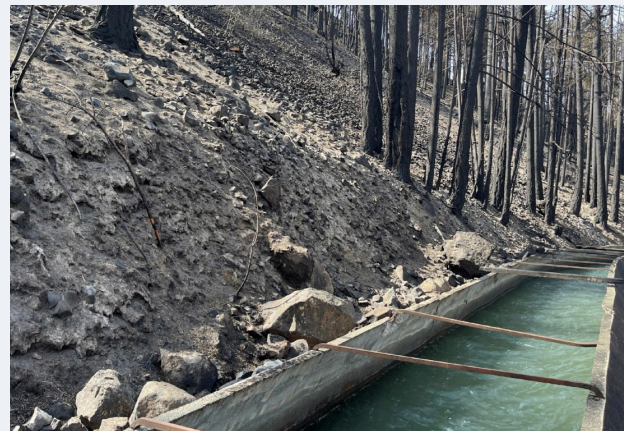
*Slope stability is one of the primary recovery concerns as the already steep slopes have been weakened by debris flows. Photo Credit: Yakima Tieton Irrigation District*
